# **O**perating Experience Insights into Below Ground Piping at Nuclear Power Plants

A Topical Report by the  
NEA Component Operational  
Experience, Degradation  
and Ageing Programme

NEA/CSNI/R(2018)2

24 May 2018

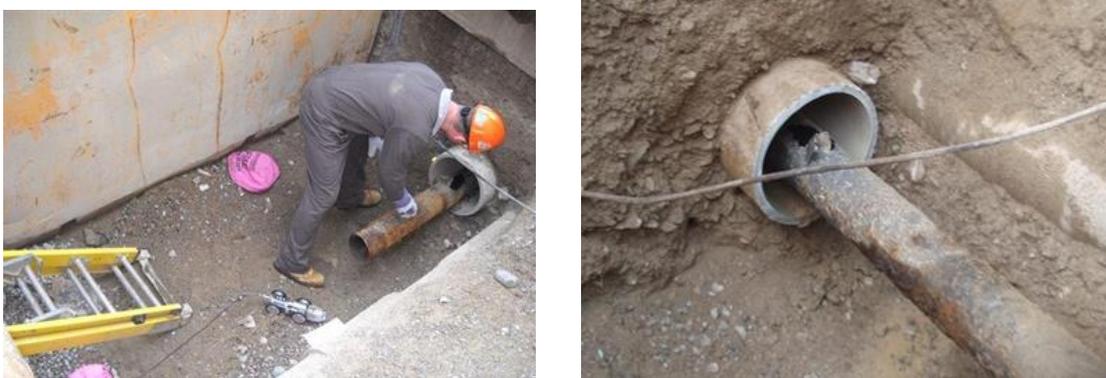
Bruce nuclear generating station, with its eight nuclear units, is among the largest power generation sites in the world. The BP programme at Bruce was initiated in 2008. Risk Classification and ranking as well as the first round of inspections involved the Fire Protection Water Supply, Emergency Water, Standby Generator Fuel line, Generator Hydrogen Storage, Carbon Dioxide, Common Service Water, Condensate Make-Up and Rejection, Lubricating Oil and LPSW systems.

**Figure 16: NPS 6 Buried Condensate Discharge Line Exhibiting Corrosion Under Insulation (CUI)**

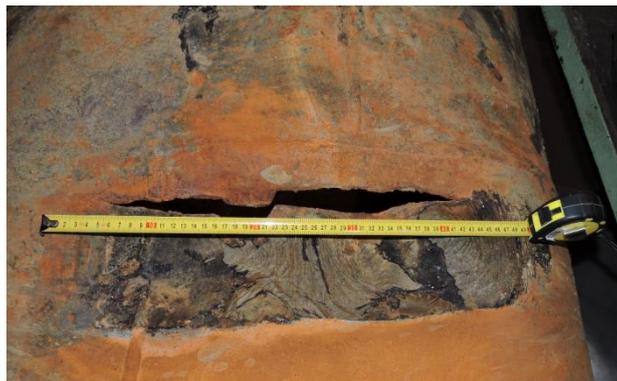
The event arose due to a minor through-wall leak in a welded joint of the DN800 Train 2 ESW piping. The leaking water then created a cavern under the pipeline, resulting in inadequate support of the affected pipe section. As the leak was located under the road used by heavy trucks going to a Ventilator Cooling Tower construction site (a post-Fukushima Daiichi plant modification project), the pipeline damage increased (Figure 17) causing the ESW Train 2 to trip and the subsequent shutdown of Dukovany Units 3 and 4.

**Figure 17: Damage to DN800 ESW Pipe<sup>22</sup>**

There was no other equipment damage, injury or a radioactivity release due to this event. As a corrective measure, the plant has inspected other underground ESW pipelines using a geo-radar (ground-penetrating radar, GPR) non-destructive testing (NDT) system. The roads crossing the

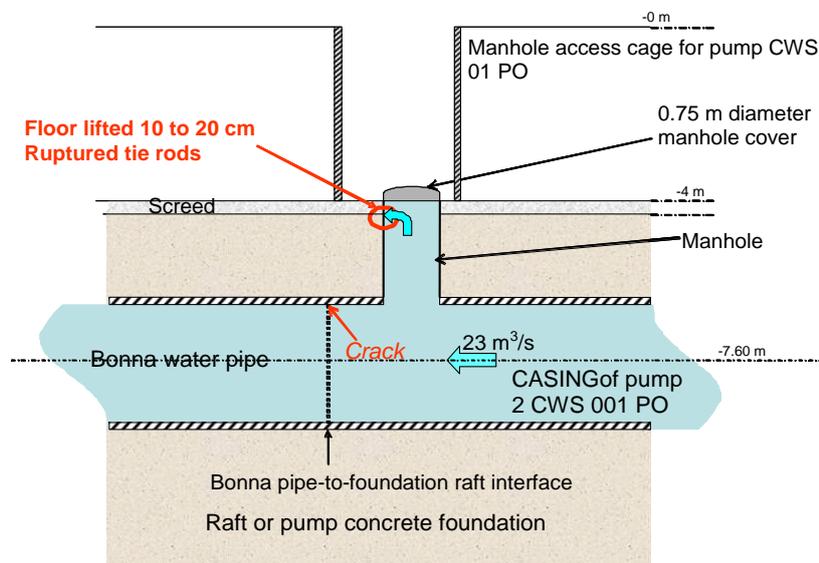
The cause of this event was a leakage at the CWS pump discharge (cracking of Bonna® pipe) to the foundation raft interface that induced a pressure rise (Figure 19). The floor was then partially lifted due to the propagation of floodwater at CWS pump discharge pressure in the concrete surface. This resulted in misalignment of the manhole, creating a leakage path between the water pipe and the turbine hall basement. The floor was lifted 10 to 12 cm higher than to the raft.

**Figure 19: Design of CWS Civil Structures**

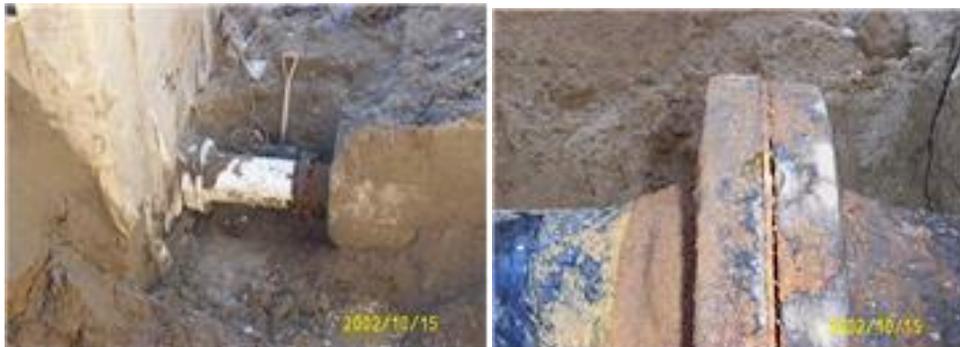
On 1 January 2013, during a field walk-down, steam was observed rising from the outdoor gravel field between the fire water pump room and the water treatment room. On 5 January, after excavating around the leak area it was determined that the leak was caused by corrosion failure of a section of the oily waste separator pipe running from the auxiliary boiler room drain line to the oily waste separator. The root cause analysis attributed the failure to flow assisted corrosion acting on the 45 degree elbow, and external corrosion of the buried pipe also took place due to the degraded condition of the anti-corrosion tape. The failed portion of the existing carbon steel elbow and pipe (6 inch diameter, wall thickness 7.1 mm, Schedule 40) were replaced with stainless steel SUS 316 pipes. The newly replaced pipe was connected to the remaining section of the buried pipe using pipe coupling, and anti-corrosion taping was applied to protect the external pipe surface (Figure 21a).

**Figure 20: The leaking flange joint of fire water supply pipe.**

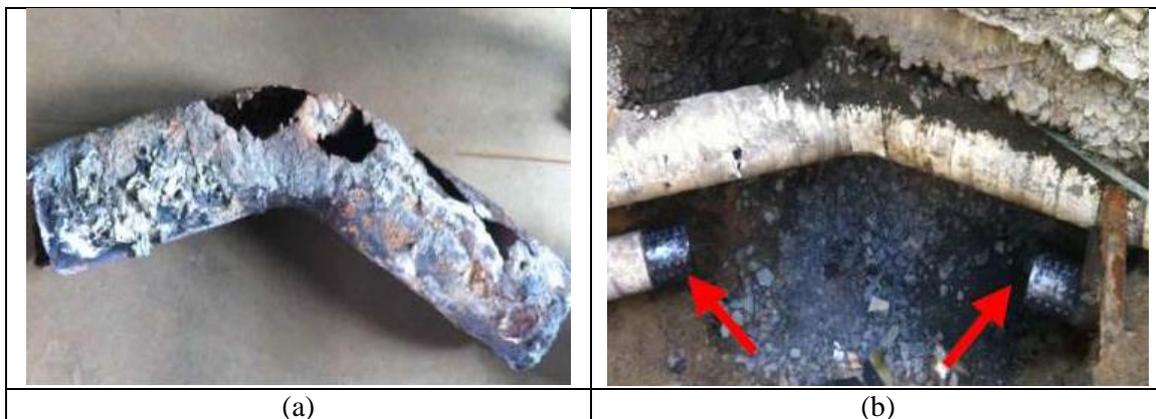
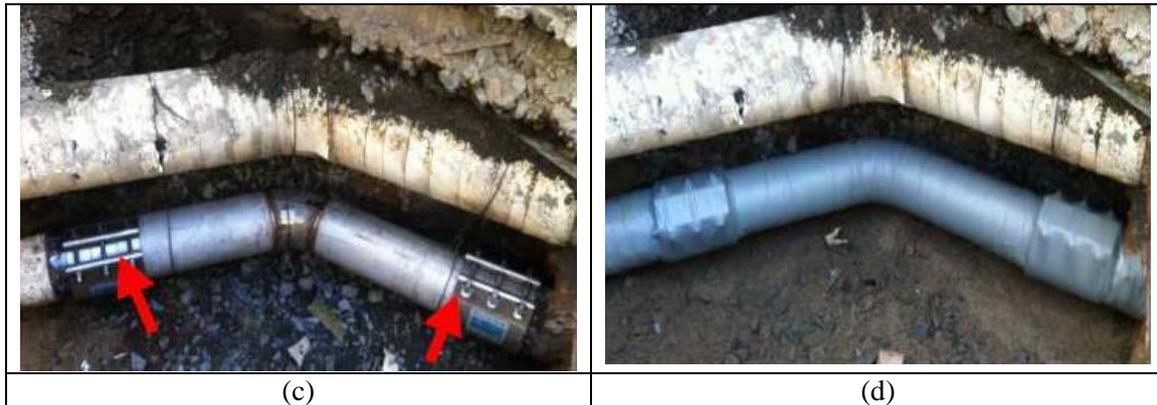
**Figure 21: a) Corroded Elbow, b) Leak Area Wall Thickness Measurement, c) Underground Buried Pipe Coupling Connection, d) Anti-Corrosion Tape**

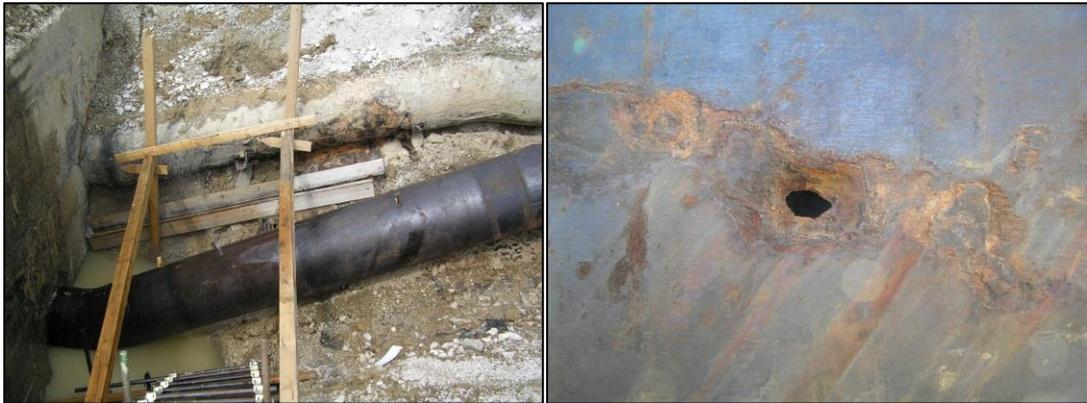
- 1999 – leak on discharge pipe DN800 on the ESW system I., locally repaired by metal welded patch.
- 2009 – 3 leaks discovered on the return pipe DN800 on the ESW system I., near the ESW cooling tower; section of pipe in the length of about 8 metres was replaced with new ones (Figure 22).
- 2011 – two local external leaks on the discharge pipe DN800 on ESW system I; these leaks were temporarily repaired using threaded sleeve anchors.
- 2013 – leaks on the pipeline providing additional water into the ESW system between the chemical water treatment building and the central pumping station.

**Figure 22: The Leaking on the Return pipe DN800 on the ESW System I Near the ESW Cooling Tower.**

- Degradation of the pipe outer surface hydroinsulation.
- Mechanical damage due to improper backfill (not according to design).
- Chemical and biological processes under damaged insulation over the lifetime.
- Original hydroinsulation end-of-lifetime.
- Lack of CP.

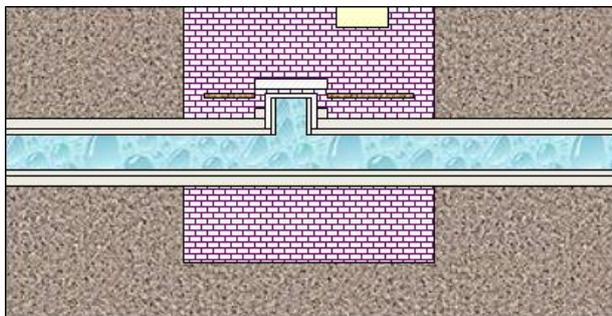
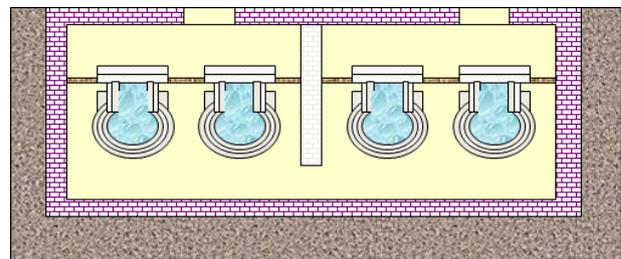
**Figure 25: Details of Below Ground ESW Piping**

The utility did not perform any thickness measurements of the manhole necks. Nor did the utility respond to earlier ESW system health reports that had warned about a process of pervasive corrosion. In response to the event<sup>30</sup>:

- The Spanish plants have developed, or are currently developing, augmented inspection programmes in order to maintain periodic surveillance of the below ground/BP systems.
- Different corrective actions have been established to eliminate or reduce problems of accessibility for the inspection of certain sections of underground piping.
- Most of the Spanish plants do not have CP systems for their underground piping or have ceased to use them. Those plants that still use such systems consider them to be a complementary method to ensure effective passive corrosion protection. Nevertheless, in the view of the Spanish regulator, the plants that have these systems in service should assess their effectiveness on a periodic basis.

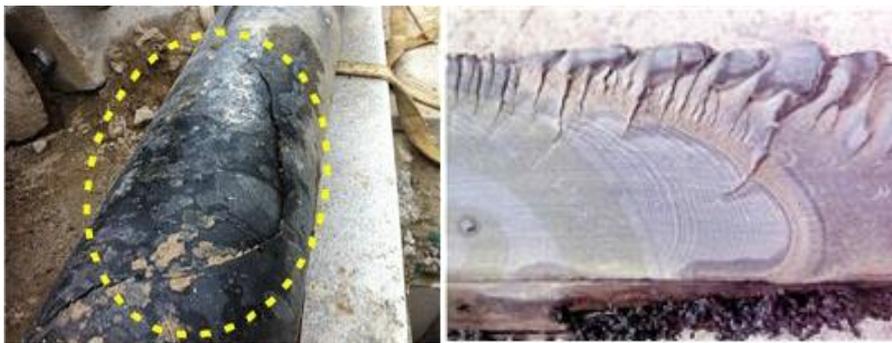
**Figure 31: Ruptured Buried HDPE Fire Water Pipe and Cross Section.**

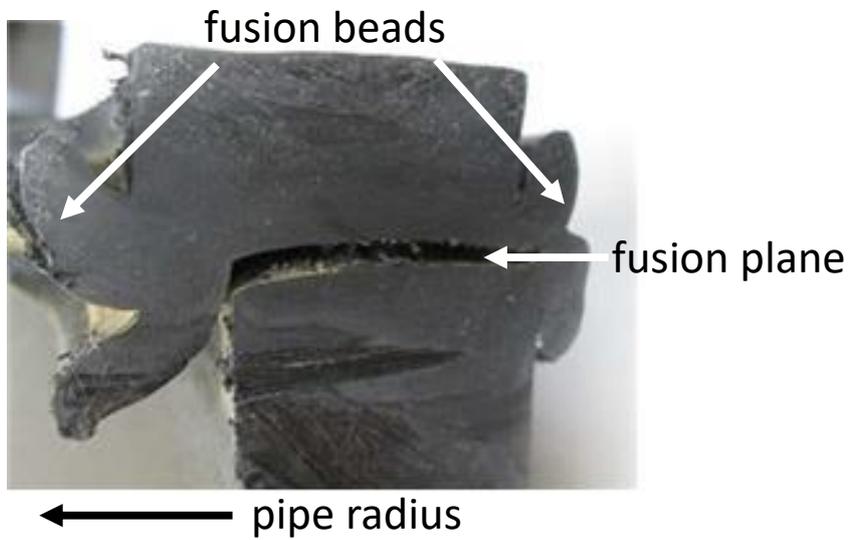
**Figure 32: Incomplete Fusion Zone.**
