# **O**perating Experience Insights into Below Ground Piping at Nuclear Power Plants

A Topical Report by the  
NEA Component Operational  
Experience, Degradation  
and Ageing Programme

NEA/CSNI/R(2018)2

24 May 2018

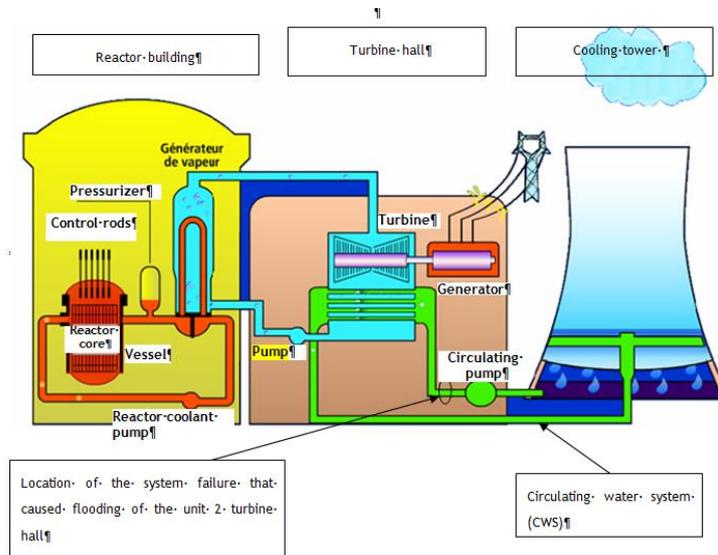
**Figure 18: Operating Principle of the Circulating Water System (CWS)**

The internal flooding event at the Nogent-sur-Seine NPP on 18 February 2006 is selected as the French representative below ground piping operating experience. Nogent Units 1 and 2 were at power when a massive water leak developed in the manhole located at Unit 2 Train 1 Circulating Water System pump discharge (Figure 18) flooded the Unit 2 turbine hall, then the Unit 1 turbine hall and the basement document storage rooms, via the tunnel connecting the two units. Both turbine halls were filled with water to a height of about 1 metre. The water then spread through non-leak tight penetration sleeves from the tunnel between the plant units to the ESW system gallery, before entering the Unit 1, Train A component cooling system (CCS) pump rooms via drains. The Nogent flooding incident resulted in the Unit 1 reactor trip. In compliance with the Technical Specifications, the operator then returned both units to normal shutdown with the residual heat system in operation.

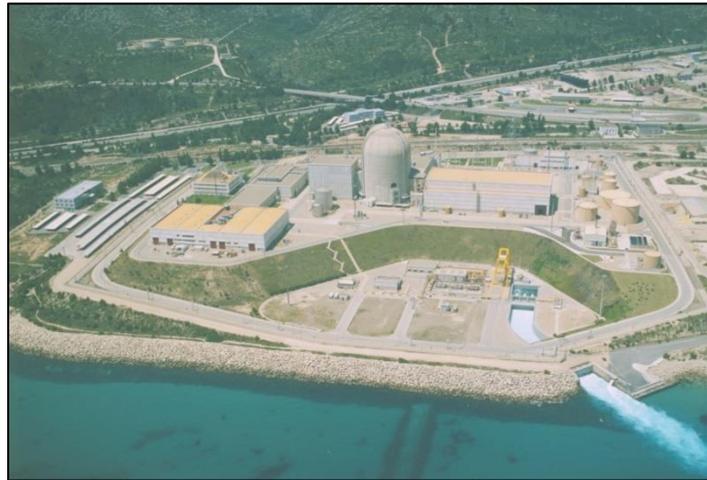
**Figure 23: Arial View of Vandellos II Ultimate Heat Sink & ESW Intake Structure**

The current approach to below ground/BP ageing management in Spain has been tempered by the regulatory and industry actions in response to the 2004 ESW pipe break at Vandellos II (Figure 23). On 25 August 2004, when the plant was operating at 100% power, a break occurred in the below ground ESW system – a Bonna® pipe system. Specifically, an 800 mm diameter standpipe failed in the manhole area EF-18-I. On the following day, the plant staff decided to make a non-scheduled shutdown in order to proceed with the repair of the affected standpipe. A visual inspection was carried out before declaring the system operable. ESW Train B was returned to service on 27 August 2004.

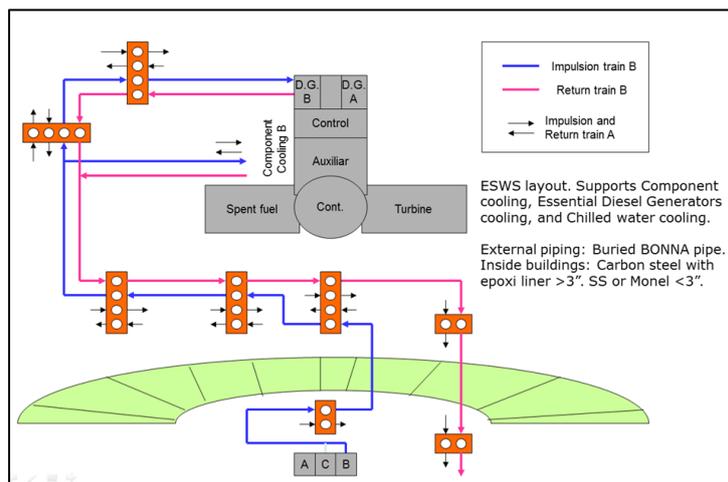
**Figure 24: ESW System General Arrangement**

In response to this event an independent root cause analysis was performed under the auspices of the IAEA and with contractor support. It was confirmed that the ESW pipe rupture occurred as a result of severe external corrosion of the standpipe. The analysis also revealed that the ESW system had been exposed to pervasive corrosion and exfoliation in the outer part of the manhole necks since 1993. This corrosion was due to inadequate protection of the steel against the erosive environment inside the hatches. Despite these findings, maintenance activities had not been improved. In the year 2000, no measurements were taken after a licensee internal inspection report had recommended an urgent measure of the thickness of EF-18-I manhole neck. On 10 May 2004, an oozing was identified in EF-18-I, the manhole neck that broke on 25 August 2004, and the utility did not declare a non-conforming status of the plant. Figure 24 shows the general arrangement of the ESW system and details of the affected section of below ground ESW piping are shown in Figure 25<sup>29</sup>.
